Manhole Inspection Summary

Manhole # S29E__027MH

Insp Date: **9/23/08 11:35 AM**

Location Address: **Voilet Hill White Way**

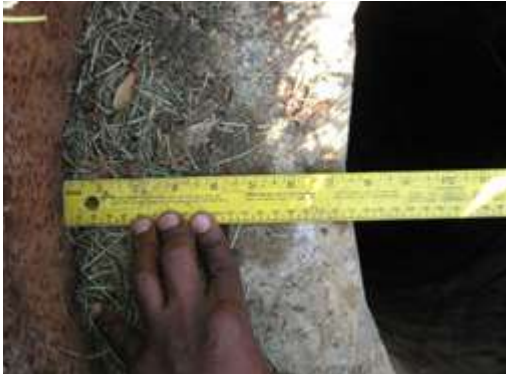
Defect 4

Frame Offset: **7.** (in.) Condition: ☒ Sound ☐ Cracked ☐ Leaks
25

Frame offset

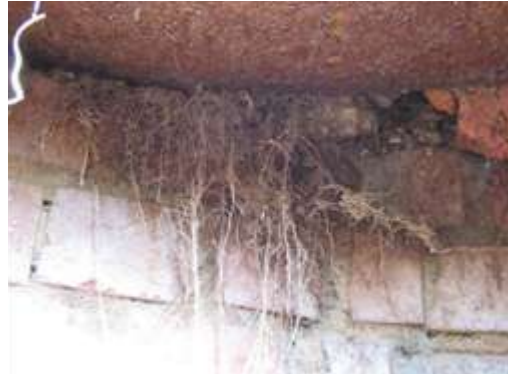
Defect 3

Infiltration: ☐ None ☐ Joint ☐ Cracks ☐ Mortar ☒ **Roots** ☐ Wall

Root infiltration

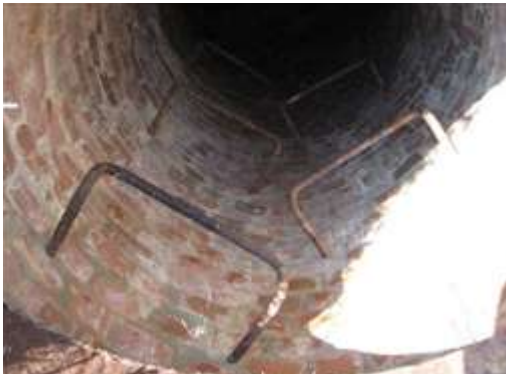
Defect 2

Steps Count: **8** Missing: **0** ☒ **Corroded**

Corroded steps

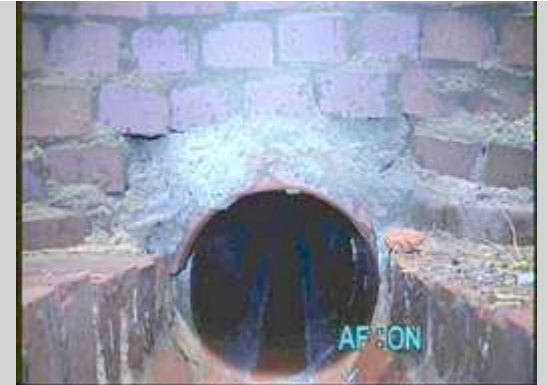
12 O'Clock Outflow

10 in. Circular Gravity Sewer
Pipe Out @ 12 O'Clock

Pipe Height: **10.8** (in.) Rod and Bar (Angled)
Pipe Material: **Clay** ☐ Pipe Lined
Invert Depth: **13.10** (ft.) Flow Characteristics: **Slow**
Deposits: ☒ None ☐ Mud ☐ Sludge ☐ Debris ☐ Grease
Silt Depth: **0** (in.) Deposits Extent:
Infiltration: **None** Pipe Seal Cond: **Sound**

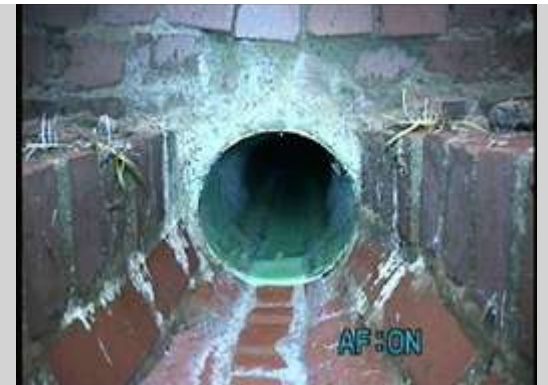
6 O'Clock Inflow

8 in. Circular Gravity Sewer
Pipe In @ 6 O'Clock

Pipe Height: **8.4** (in.) Rod and Bar (Angled)
Pipe Material: **PVC** ☐ Pipe Lined
Invert Depth: **12.92** (ft.) Flow Characteristics: **Slow**
Deposits: ☒ None ☐ Mud ☐ Sludge ☐ Debris ☐ Grease
Silt Depth: **0** (in.) Deposits Extent:
Infiltration: **None** Pipe Seal Cond: **Sound**
